Service Alert

Topic: TruiDL Logger – Potential Damage to Voltage Sensor Wires

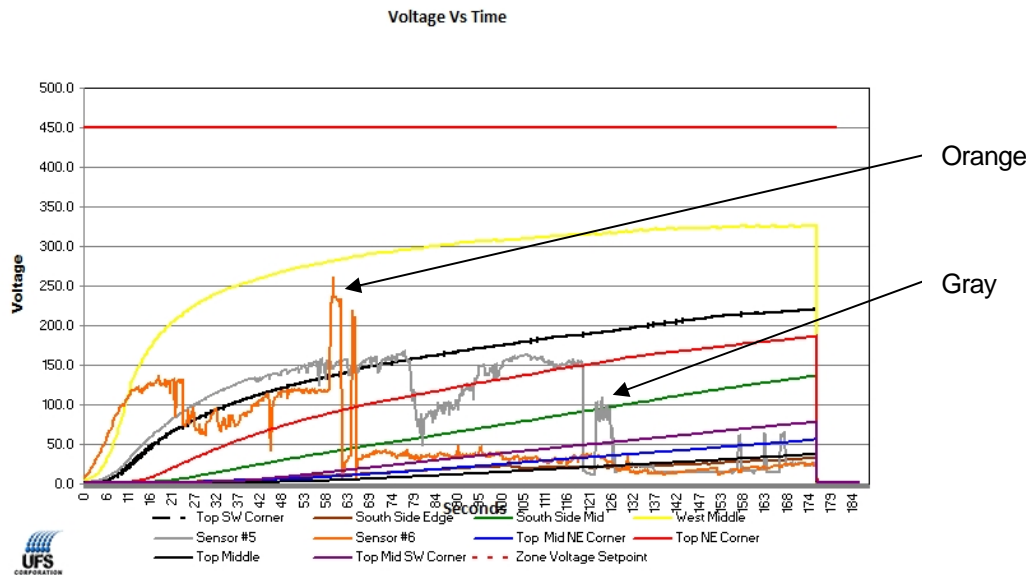
The normal curve from a data run is generally upward trending and smooth. However in the plot shown below the Gray (#5) and Orange #6) begin their rise, but then suffer a rapid drop off.

One of the conditions that can lead to this occurrence is the flow of a small amount of current into the Sensor probe tip and then to a ground source of some type. In this case both the Gray and Orange sensor tips showed evidence of paint on them after they were removed before the oven.

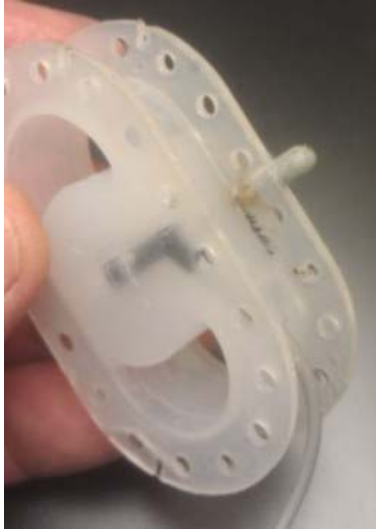
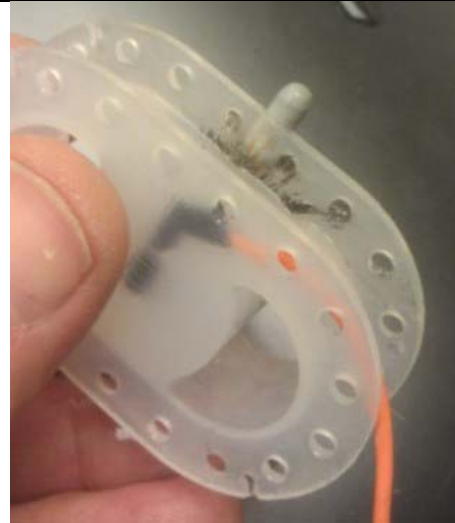
The Voltage Harness was used the following day (probe tips had been cleaned off before the second run) and the same two curves showed similar behavior as the day before. When the wires were inspected, a small defect in the insulation was found. The placement of the defect suggested the cause was the wire retention slot.

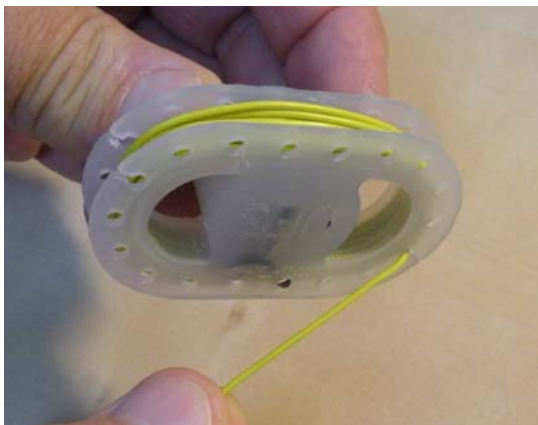
The photo below depicts how NOT to use wire retention slot after you are finished winding the excess wire on the spool.

Do not use one hand to force the wire into the wire capture slot.

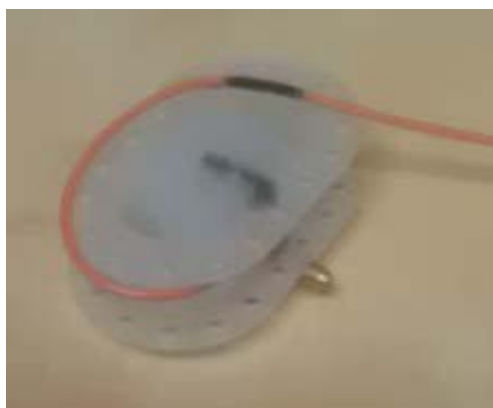
What to do if a voltage sensor wire insulation is nicked or cut?

The defect in the insulation must be covered over in order to get the sensor to begin reporting accurate voltage again. The damaged portion of the wire insulation can be covered with a 'liquid electrical tape' product. Another method is to use heat shrink. This is described in the TruIDL Equipment Manual.
