UFS Corporation

Service Reference

Topic: Fast Dissolution of Precious Metal Electrodes (PME)

“My inert Electrodes are wearing out fast!”

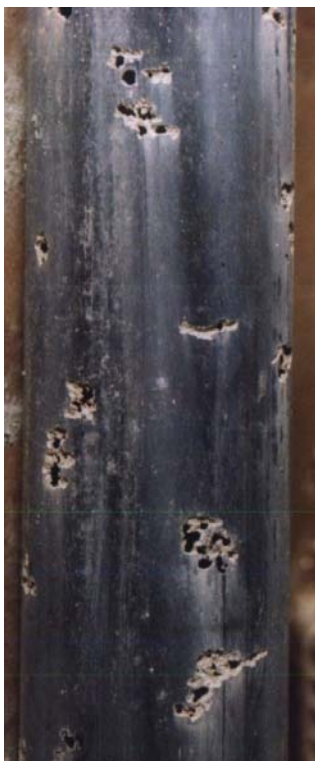
Figure 1. (Surface Pitting)

Generally an issue only seen with Cathodic ED systems, the rapid dissolution of the PMx (precious metal type) anodes comes as a surprise. What is fast dissolution of PMx? Once the PME coating has lost about 30% of it’s original coating, the anode (Titanium) surface is at risk for developing pits (*Figure 1*) and you should think about replacing them. The pits generally start low on the anode on the side facing the ware. In some cases the pits then migrate around the bottom of the anode, or in other cases the pits migrate up the face of the anode on the side closest to the ware.

Figure shows how pits have penetrated through the Ti tube. Figure 2 shows light colored regions. Generally these light colored regions have a color close to 'battle ship' gray. The third failure mode is referred to as loss of adhesion (between the PMx oxide coating and the Ti tube). This is evident if you hold the tube and then look at your hand. If you see black material on your hand then this may be an issue. It is typical to see some amount on you hand, but the more than comes off indicates a failure is in progress.

There are several things that should be done: 1) Never allow city water (or other high conductivity water) into the e-coat paint system; and 2) Ask the E-coat paint supplier for their recommendation of an appropriate additive to reduce the chance of a high PME dissolution problem. (UFSc can help the E-coat paint supplier in this selection process.) 3) Be careful not to allow halides to enter the ED paint bath of the anolyte solution. These are sometimes used as active ingredients in fungicides and biocides.

- Record the conductivity of the anolyte every day on a bulletin that is offered by UFSc (Service Reference #990127).
- Record both the ED Bath pH and the anolyte pH on above mentioned Service Reference #990127.
- Add the anolyte anti-corrosive additive (recommended by the ED paint supplier and UFSc) on a regular basis since the anolyte is always being turned over and lost as the conductivity controllers add fresh DI water.
- Begin a process of visually inspecting (with hand-held or portable 10x microscope) a sample of the PMx every six months or so. Graph this data and use it to predict when to replace your electrodes (generally when you have less than 30% of the original coating mass left
 - as measured with an x-ray test instrument).
- Record a process by which you inspect the PMx for excessive corrosion. (Request UFSc Bulletin #990161.)

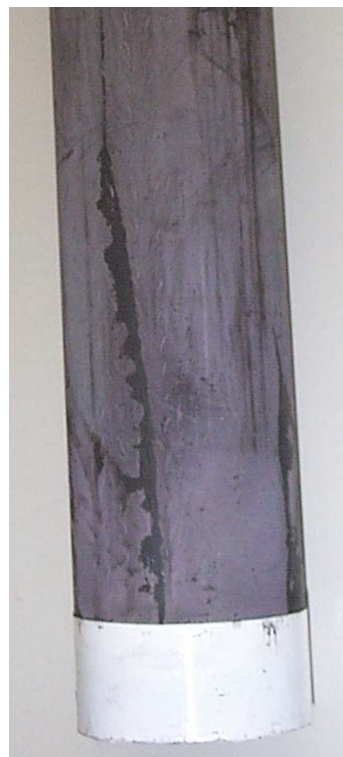
**Figure 2. (Typical Loss of Coating)**

| Anolyte Component | Level of Concern | Possible Effect to Anode |
|---|---|--|
| Organics | 1 ppm | EDTA causes coating loss (<i>Figure 2</i>) and premature coating failure. However, each organic must be addressed on a case-by-case basis. Some organics form a deposit on the anode coating which will result in increased voltage. |
