Service Alert

Topic: TruiDL Logger – Potential Damage to Voltage Sensor Wires

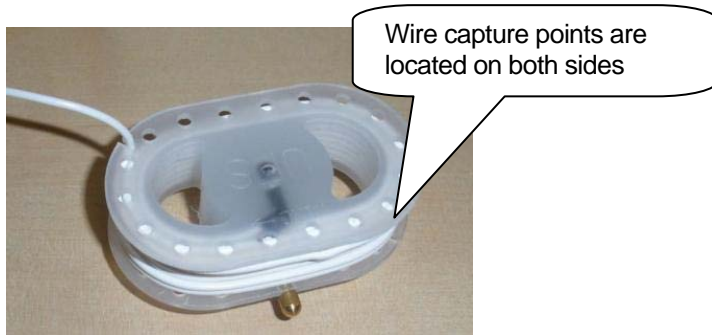
The TruiDL Logger will measure and record the voltage near the surface of the ware as it travels through the E-coat bath. The voltage signal is collected via a wire to a sensor. Excess wire is wound out of the way on an integrated spool as shown below –
